**DEPARTMENT OF TRANSPORTATION**

Contract #: 04-0120F4Cty: SF/ALA Rte: 80 PM: 13.2/13.9File #: 69.28**WELDING INSPECTION REPORT****Resident Engineer:**Pursell, Gary**Address:** 333 Burma Road**City:** Oakland, CA 94607**Report No:** WIR-011902**Date Inspected:** 29-Jan-2010**Project Name:** SAS Superstructure**OSM Arrival Time:** 645**Prime Contractor:** American Bridge/Fluor Enterprises, a JV**OSM Departure Time:** 1845**Contractor:** Zhenhua Port Machinery Company, Ltd (ZPMC), Changxing Island **Location:** Shanghai, China**CWI Name:** Zhao Chen Sun.**CWI Present:** Yes No**Inspected CWI report:** Yes No N/A**Rod Oven in Use:** Yes No N/A**Electrode to specification:** Yes No N/A**Weld Procedures Followed:** Yes No N/A**Qualified Welders:** Yes No N/A**Verified Joint Fit-up:** Yes No N/A**Approved Drawings:** Yes No N/A**Approved WPS:** Yes No N/A**Delayed / Cancelled:** Yes No N/A**Bridge No:** 34-0006**Component:** Tower Components**Summary of Items Observed:**

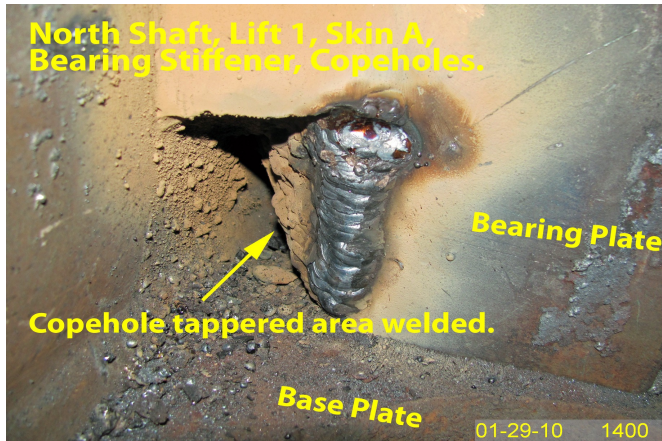
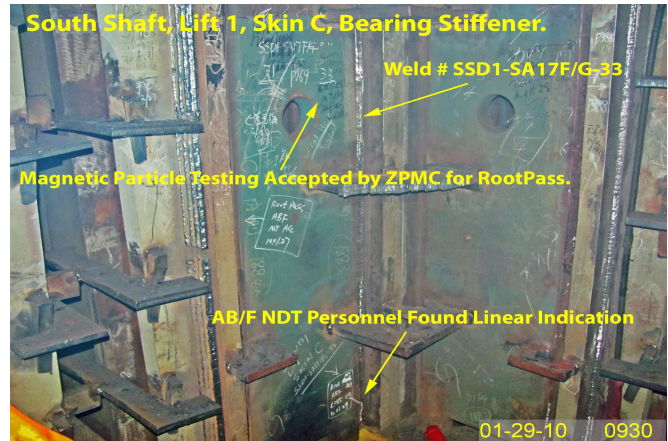
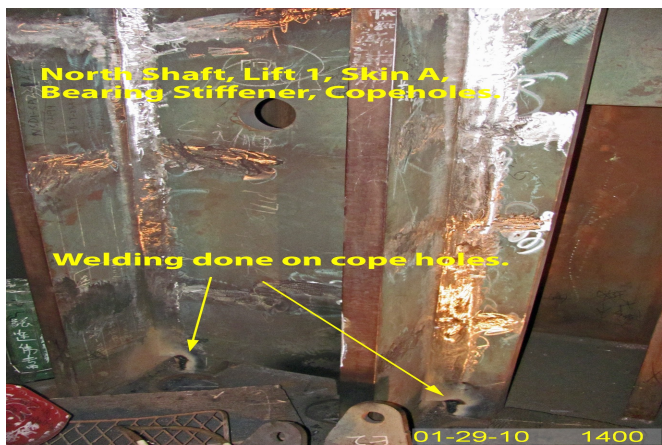
During the Quality Assurance (QA) random in-process visual inspection of South Tower Lift 1 Bearing Plate groove weld, this QA inspector observed AB/F NDT Personnel performing Magnetic Particle Testing(MT) for root pass. This is Partial joint Penetration Joint(PJP). Weld Identified as SSD1-SA17F/G-33.

AB/F QA found Linear Indication on the weld. The weld was previously tested & Accepted by ZPMC. The indication observed was inside the ZPMC NDT coverage area.

ZPMC grinded that Indication out & AB/F accepted the weld root pass after confirming it by MT. The attached photographs provide additional detail.

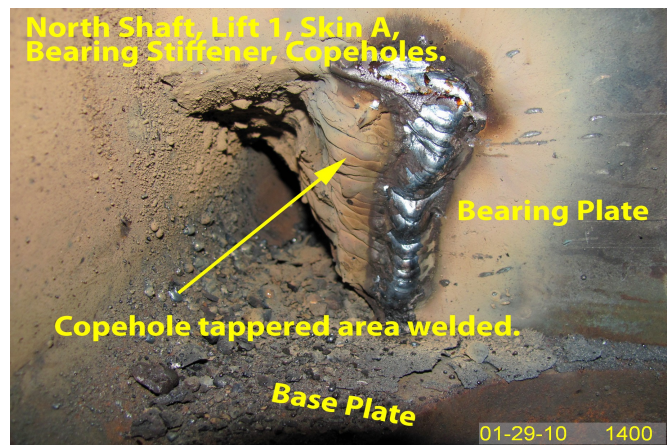
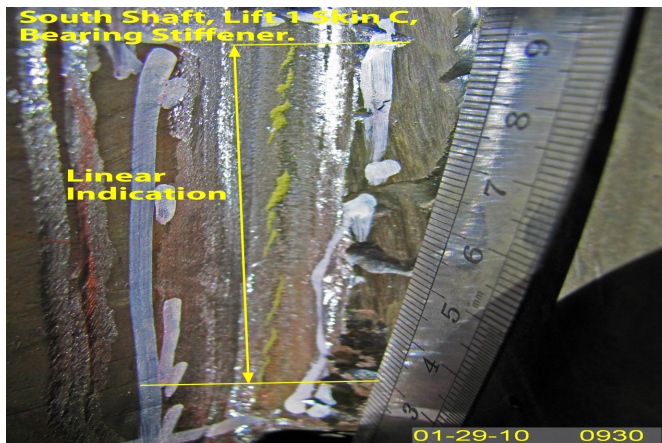
During the Quality Assurance (QA) random in-process visual inspection of North Tower Lift 1 Bearing Stiffener Copeholes, this QA inspector observed welding has been done on the tapered portion of bearing plate at the location of copehole. The attached photographs provide additional detail.
